# RESEARCH MEMORANDUM

FULL-SCALE HYDRODYNAMIC EVALUATION OF A

MODIFIED NAVY J4F-2 AMPHIBIAN WITH A

0.425-SCALE XP5M-1 HULL BOTTOM

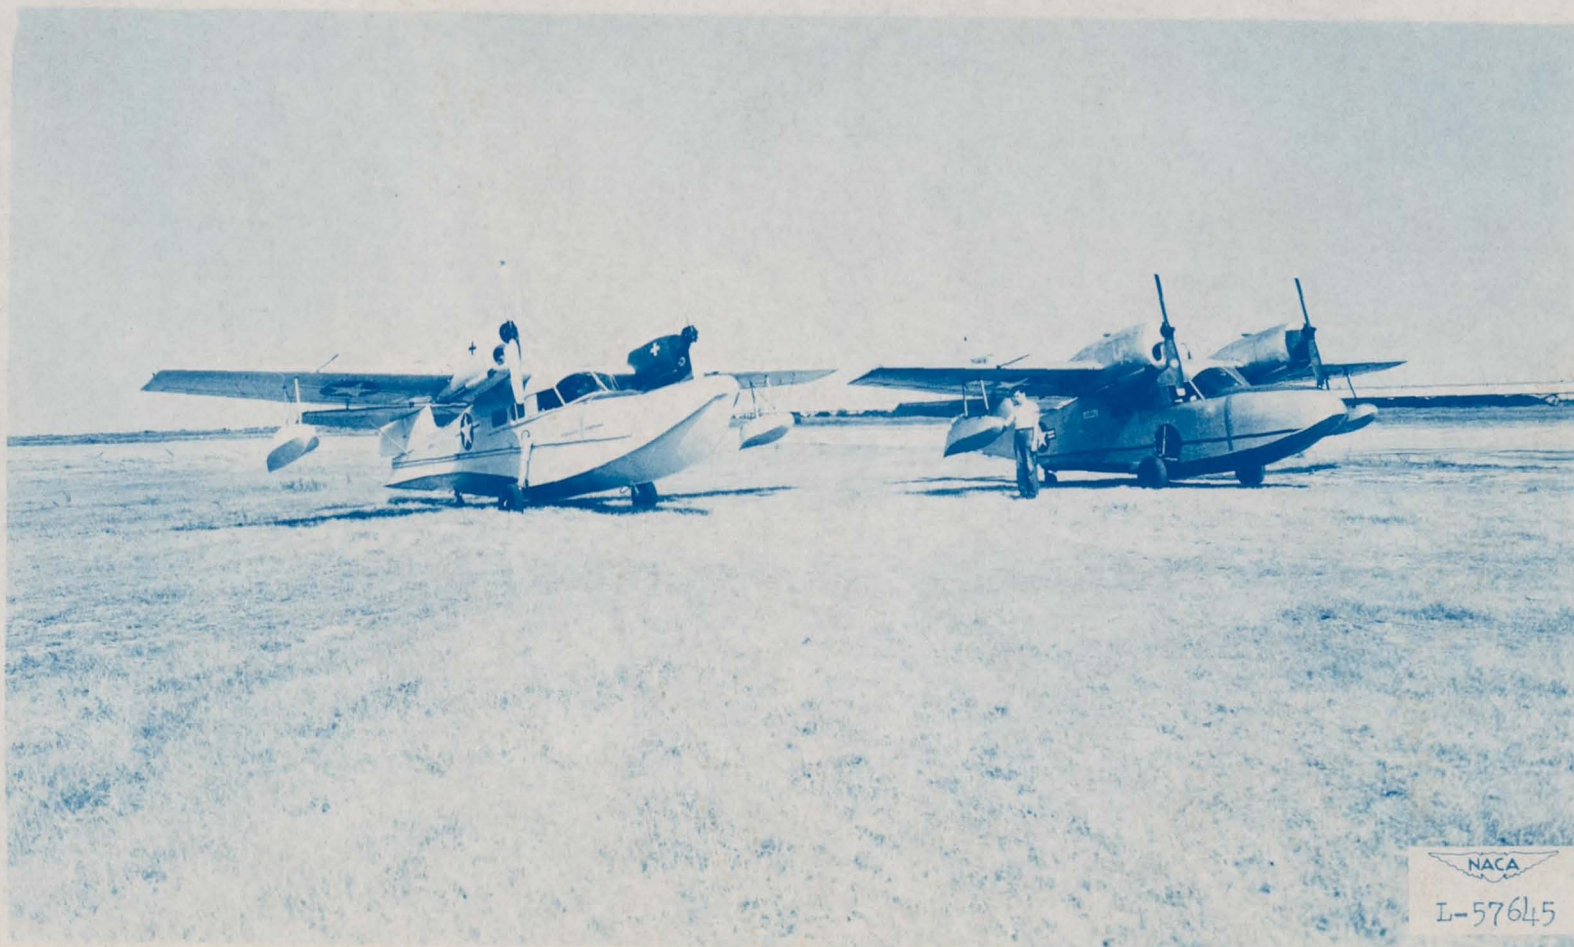
Figure 2.- Three-quarter front view of J4F-2 with 0.425-scale XP5M-1 hull bottom and standard J4F-2.

The airplane, as modified by the Edo Aircraft Corporation, incorporated a splice line in the skin and frames above the chines so that any of several hulls could be installed. Above this splice line the airplane had only minor modifications which resulted in a slightly reduced rudder area and a landing gear that retracted back and up under the wing instead of into the fuselage. Photographs of the modified airplane and the standard J4F-2 airplane are shown as figures 1 and 2. A three-view drawing is shown in figure 3 and the pertinent dimensions are listed in table I. A lines drawing of the hull is shown in figure 4.
